### Inspection Report Minerals Regulatory Program

**Mine Name:** Bonanza  
**Operator Name:** American Gilsonite

**Permit number:** M0470010  
**Inspection Date:** April 12-13, 2006  
**Time:** 11:30 AM on April 12 to 11:30 AM on April 13

M0470010, Bonanza Mine, American Gilsonite

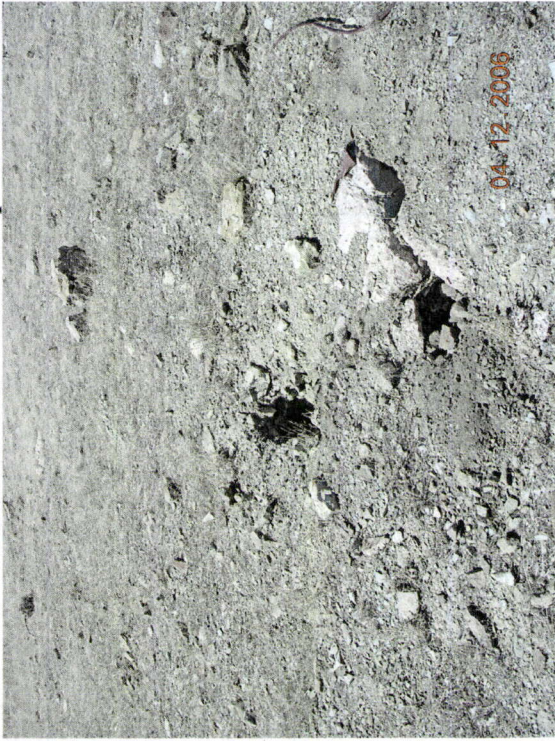
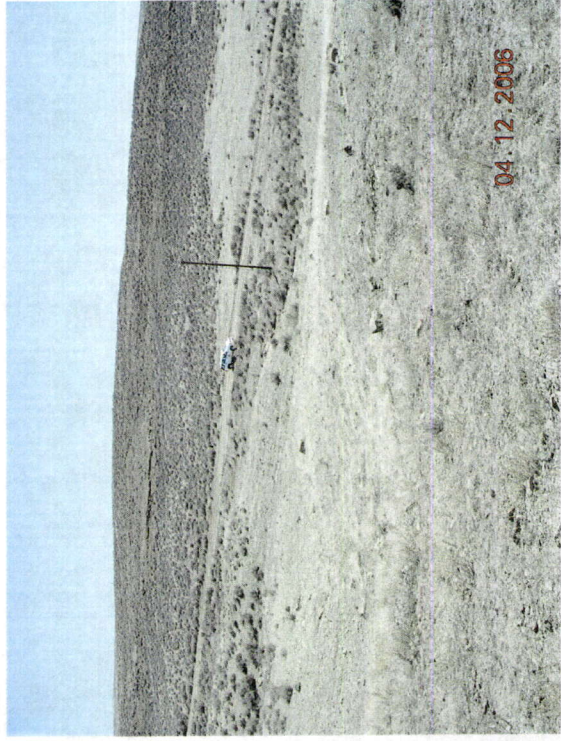
| Site(s) | Photo(s) | Comments |
|---|---|---|
| LE5 | 1 & 2 | Reclaimed. We couldn't find a cap. It may have been backfilled with concrete, but there were some piping or rodent holes. Vegetation consists of cheatgrass, halogeton, sagebrush, and rabbitbrush. |

Photo 1. LE5. We found some evidence of piping or rodent burrows.

Photo 2. Overview of LE5 area.

I recommend that remedial measures be taken to establish vegetation on sites LE5, LE10, LE16, LE19, and LE20. It is very difficult to establish perennial vegetation into cheatgrass-infested areas unless something is done to reduce cheatgrass competition.

There are a few alternatives for establishing vegetation in these areas. I recommend that the operator use a fall application of Plateau herbicide. The sites would be roughened followed immediately by seeding and application of Plateau at a low rate, probably about 2-3 ounces per acre. Plateau needs to be mixed with a methylated seed oil.

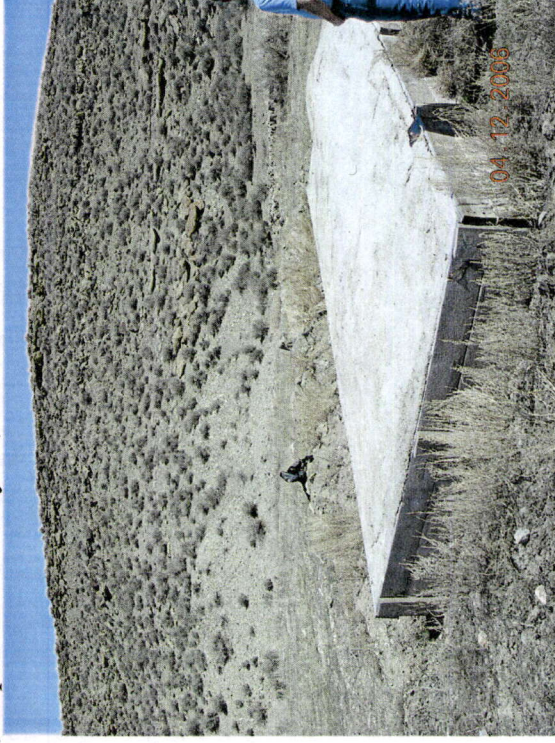
| Site(s) | Photo(s) | Comments |
|---|---|---|
| LE6 | 3 | Reclaimed. Vegetation is mostly halogeton, cheatgrass and greasewood. Large, mounded cap. It looks like dirt was pulled back when the cap was installed but that it was never put back against the cap which we recommend to reduce piping. |

Photo 3. LE6. We suggest dirt be pushed back to the edge of the cap.

We suggested that dirt be mounded to the edge of the cap at LE6.

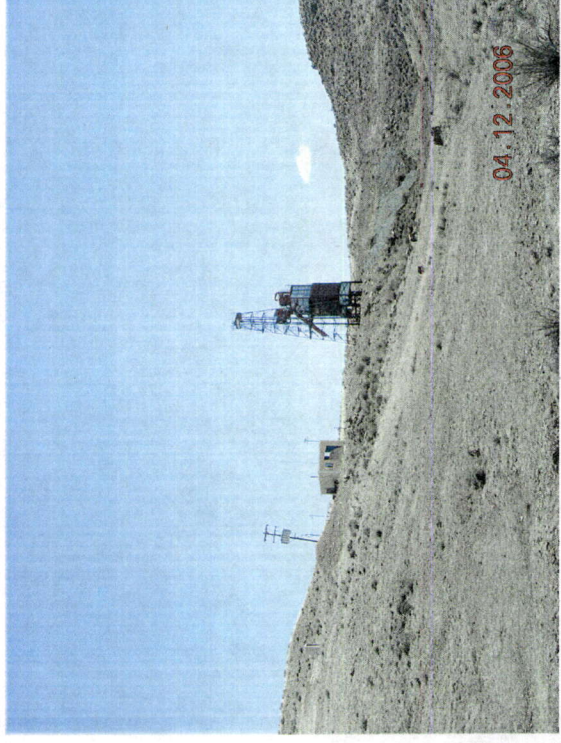
Photo 4. LE7.

| Site(s) | Photo(s) | Comments |
|---|---|---|
| LE7 | 4 | Has equipment but not active. |

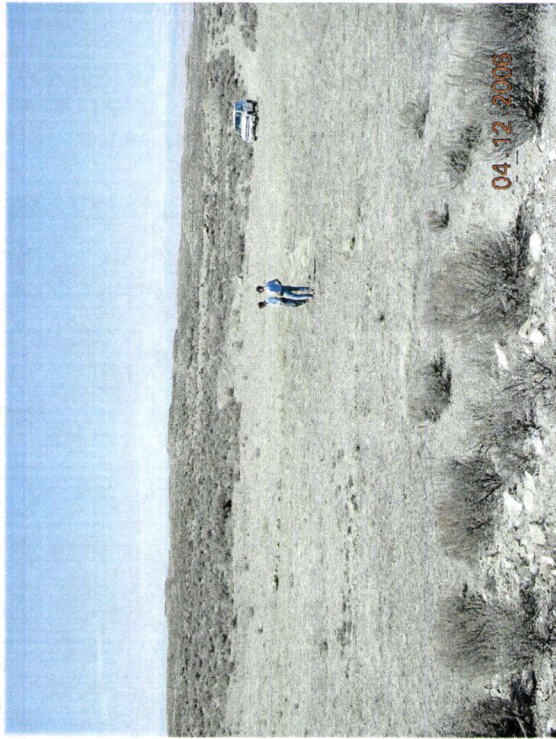
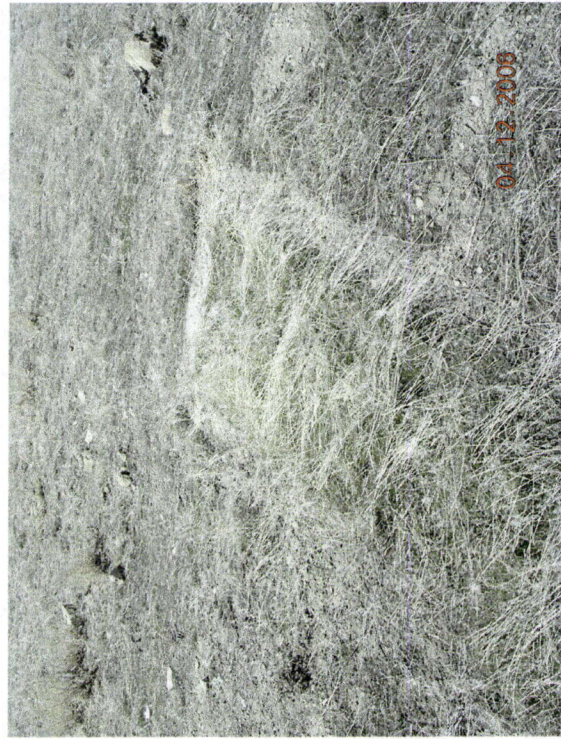
| LE16 | 5 & 6 | Reclaimed. Vegetation mostly cheatgrass. |

Photo 6. LE16. We believe the shaft was here.

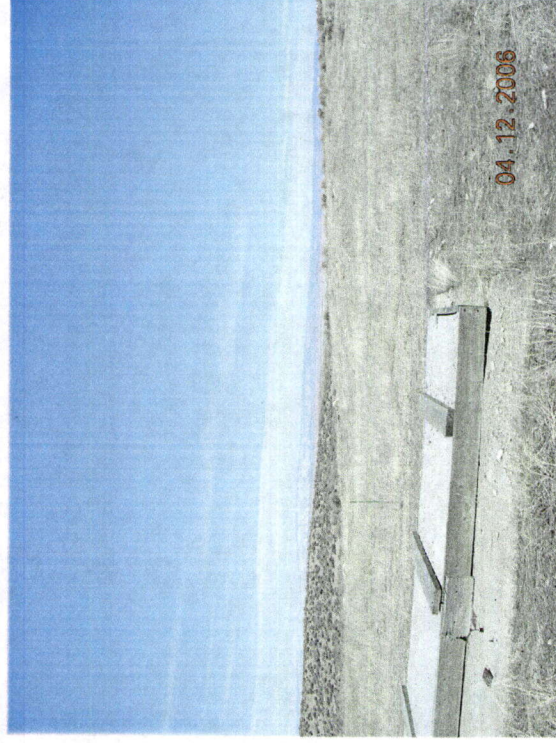
Photo 7. LE19.

| LE19 | 7 | Reclaimed. Vegetation mostly cheatgrass. |

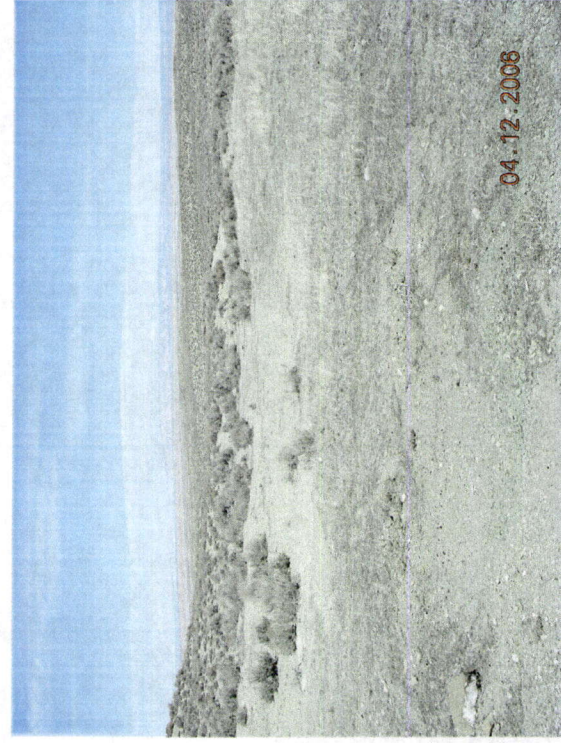
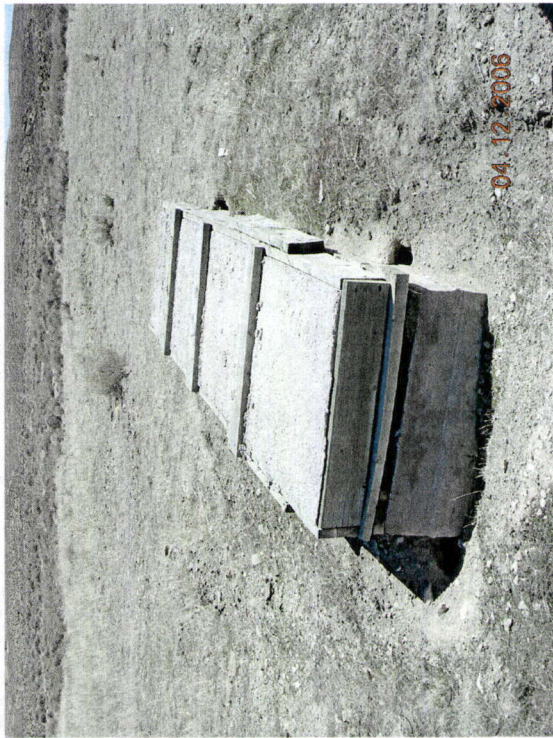
Photo 8. LE20.

| LE20 | 8 & 9 | Reclaimed. Some burrowing around edges of cap. Vegetation mostly cheatgrass. |

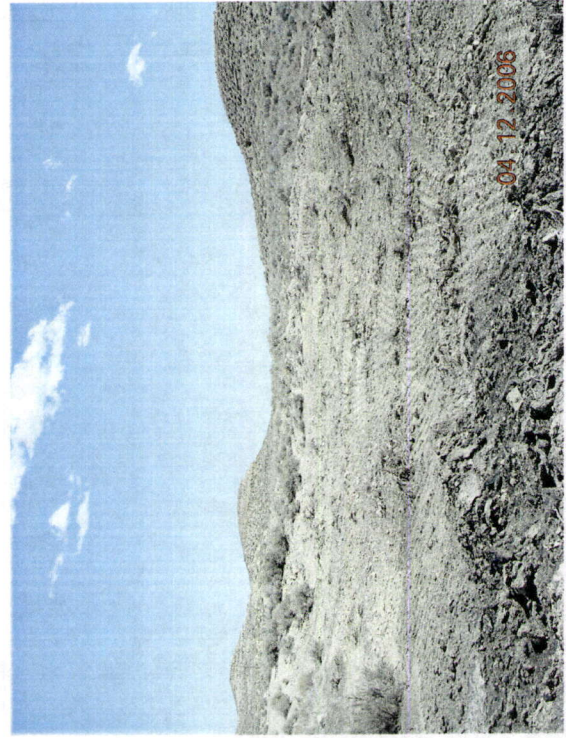
Photo 10. WH10.

| WH10 | 10 | Reclaimed. This site and WH11, 12, and 13 were all capped, and they were seeded in the late summer or fall of 2005. The caps were buried. |

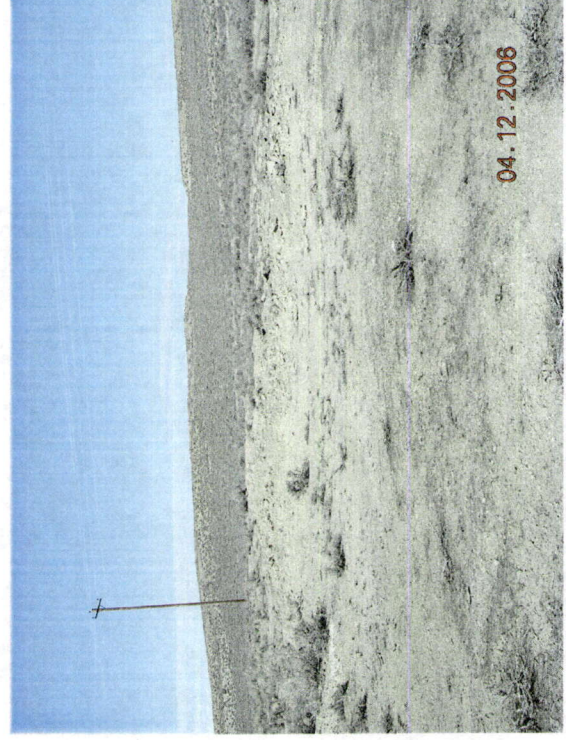
Photo 12. WH12.

| WH12 | 12 | See comments for WH10. |

WH12 appears to be adequately reclaimed except for revegetation. I see no problem with giving the partial release the operator has requested. The site is on BLM land, so the Division will need to receive their concurrence.

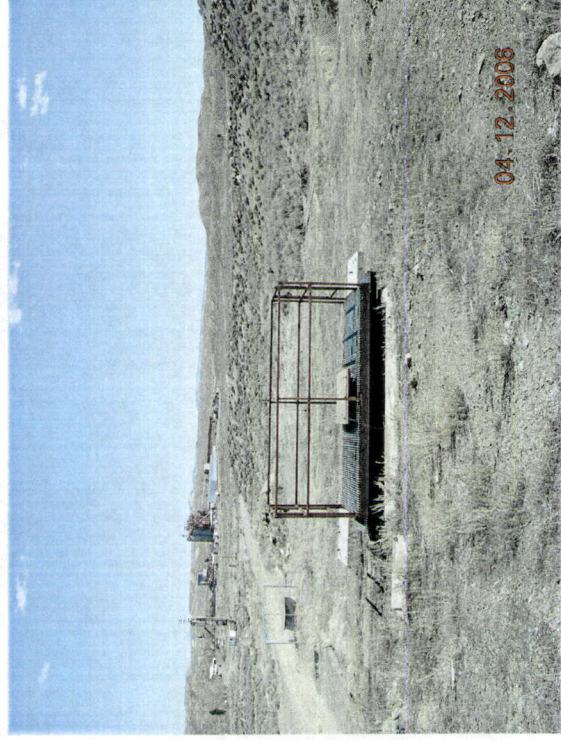
Photo 4. B28?

| B28 | 4 | Partly reclaimed. Some footings still present, but cap has been poured. |

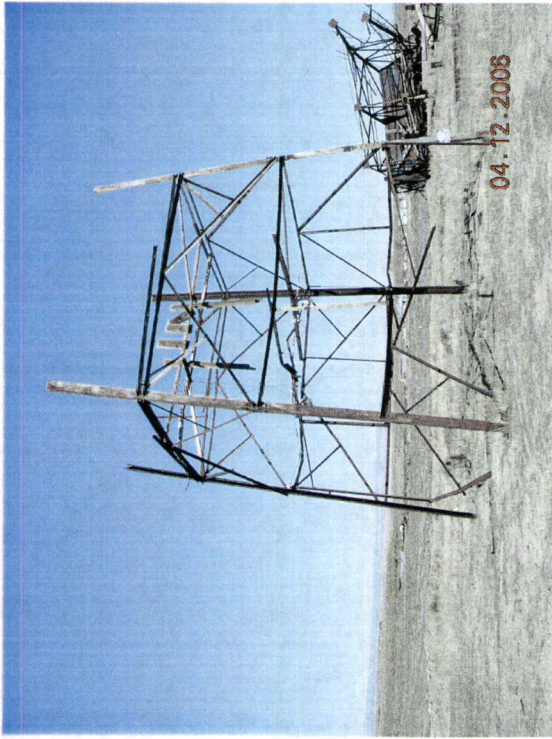
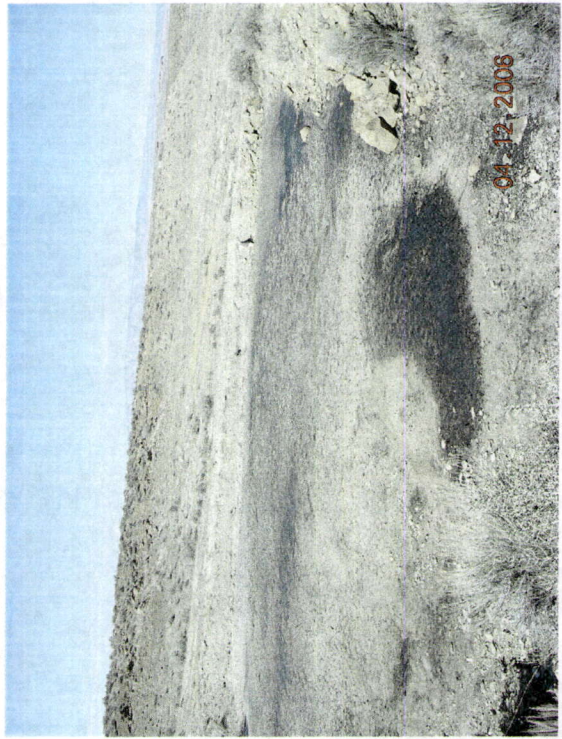
| B38 | 5 & 6 | Partly reclaimed. Most equipment gone; only the headframe and some scrap remain. There is an impoundment that looks like a sediment pond. This site is more than one acre. |

Photo 5. B38.

Photo 6. Sediment pond at B38.

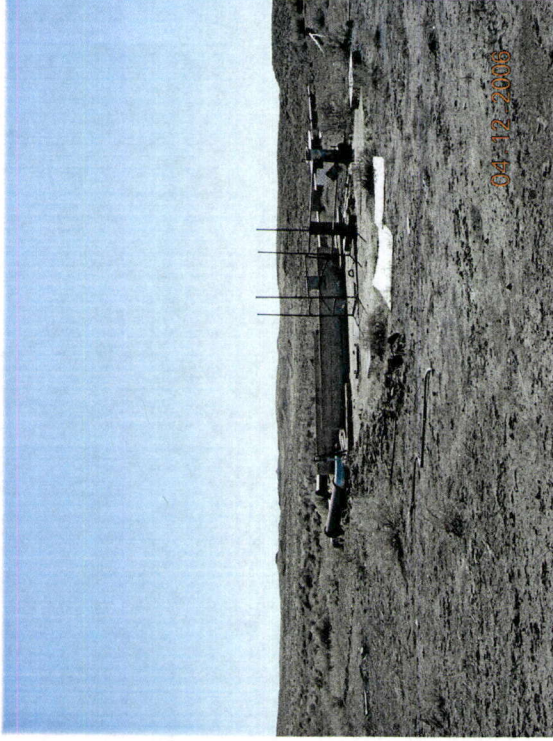
Photo 7. B42.

| B42 | 7 | Partly reclaimed. Hoist house gone. No cap. Some equipment still present. |

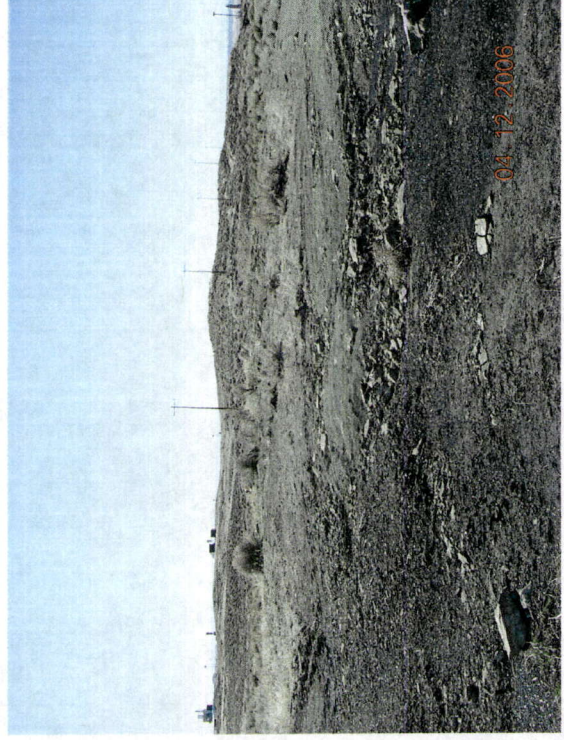
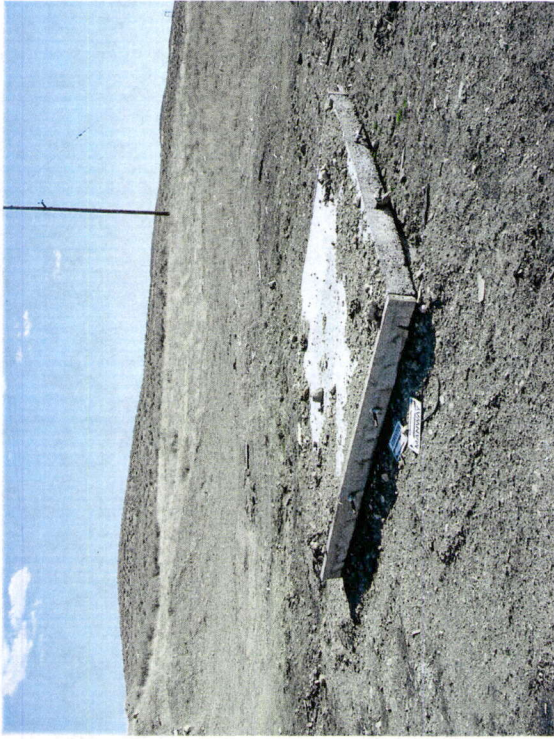
| I16 | 16 & 17 | Reclaimed. Rebar in the cap is widely spaced (about 7 feet). Little vegetation. |

Photo 16. I 16.

Photo 17. I 16.

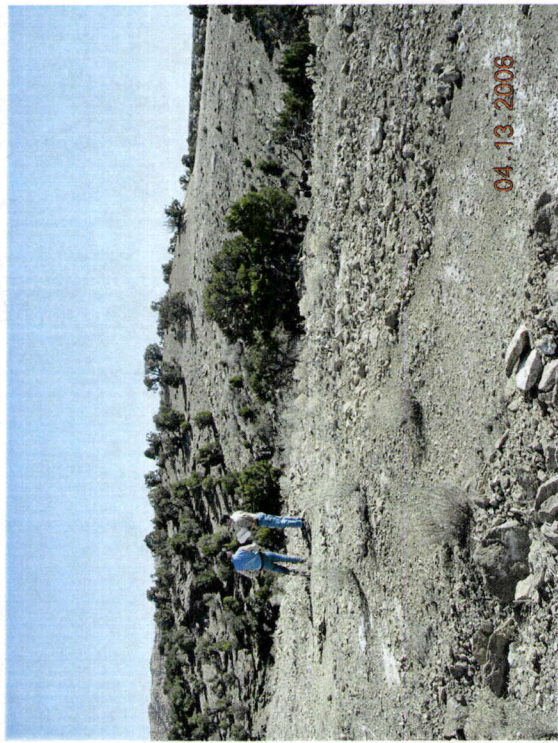
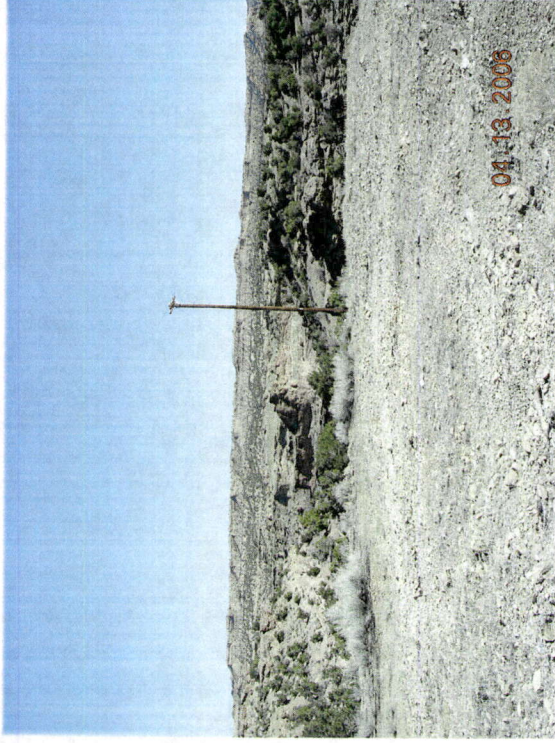
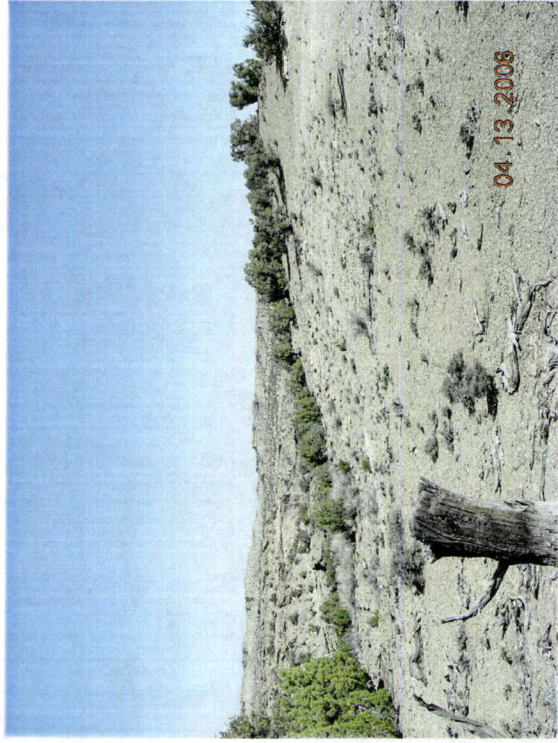
| H2 | 14, 15, & 16 | Reclaimed. Shaft closed with polyurethane foam (PUF) with no signs of failure. Access road being used by gas companies. Perennial cover 5.1 percent in reclaimed area and 3.1 percent on ridge in undisturbed area. The roads leading to the site are driveable, and it appears they may receive use from an oil or gas company. |

Photo 14. H2.

Photo 15. H2.

Photo 16. Undisturbed ridge near H2.

I will recommend that sites R2, R4, H2, and H10 receive final release. According to my notes, site B40 still needs to be seeded in 2004. Although there may be enough vegetation cover to meet release criteria, it has not been three years since the site was seeded if this happened in 2004.

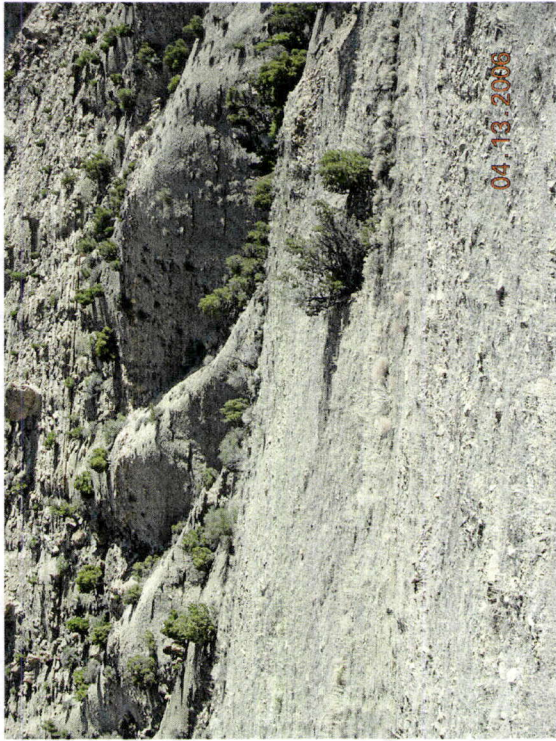
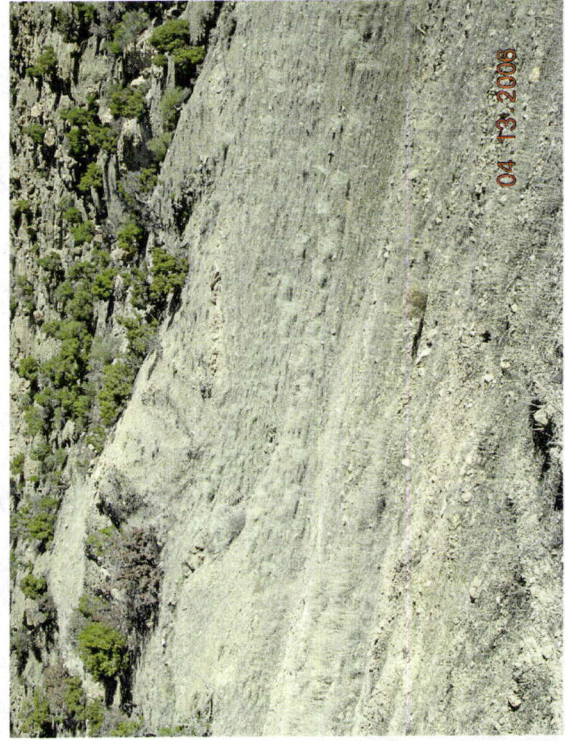
| H10 | 17 & 18 | Reclaimed. Shaft closed with PUF with no signs of failure. Reclaimed area has 7.7 percent perennial cover, and undisturbed understory has 6.4 percent. Portions of the road being used for oil and gas development. Part of the road to this site (#15) is reclaimed, and part is being used to access an oil or gas well. |

Photo 17. H10.

Photo 18. H10.

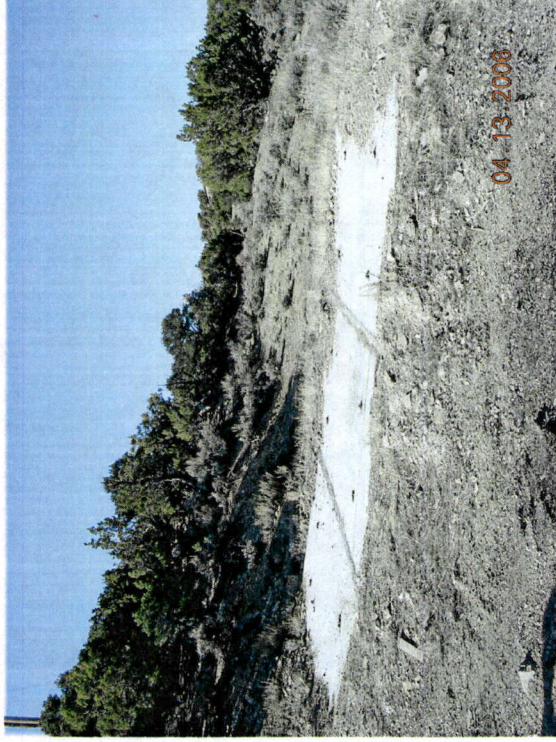
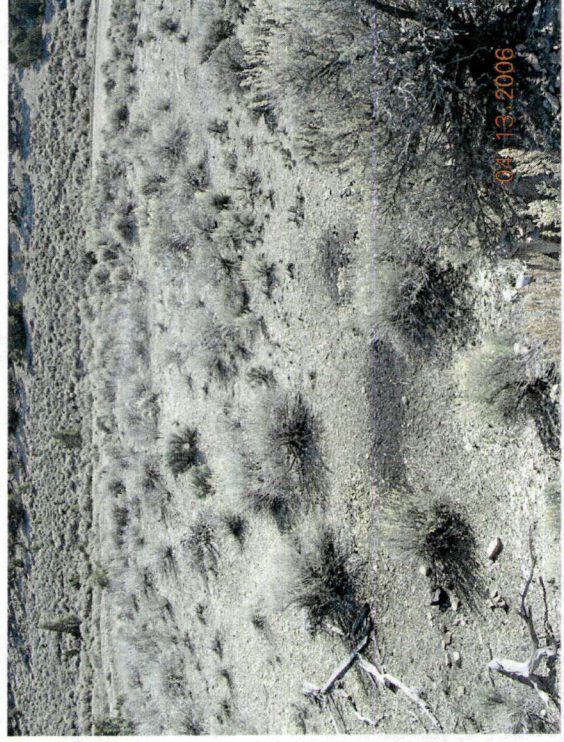
| R2 | 19 & 20 | Reclaimed. Shaft covered with 3 concrete slabs. Vegetation is mostly sagebrush from natural invasion. |

Photo 19. Cap on R2. Since the last inspection, the operator sealed the cracks between the concrete slabs.

Photo 20. Vegetation at R2.

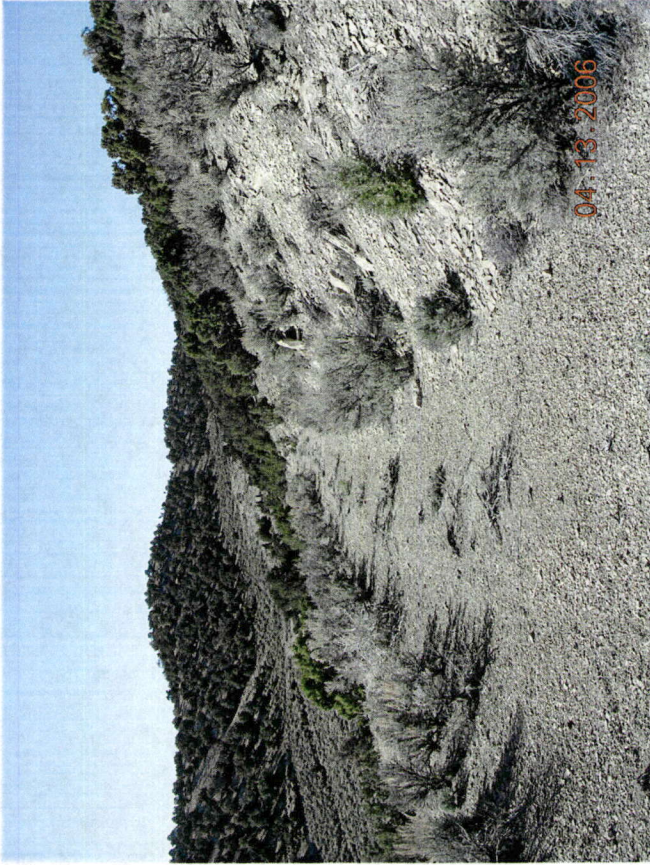
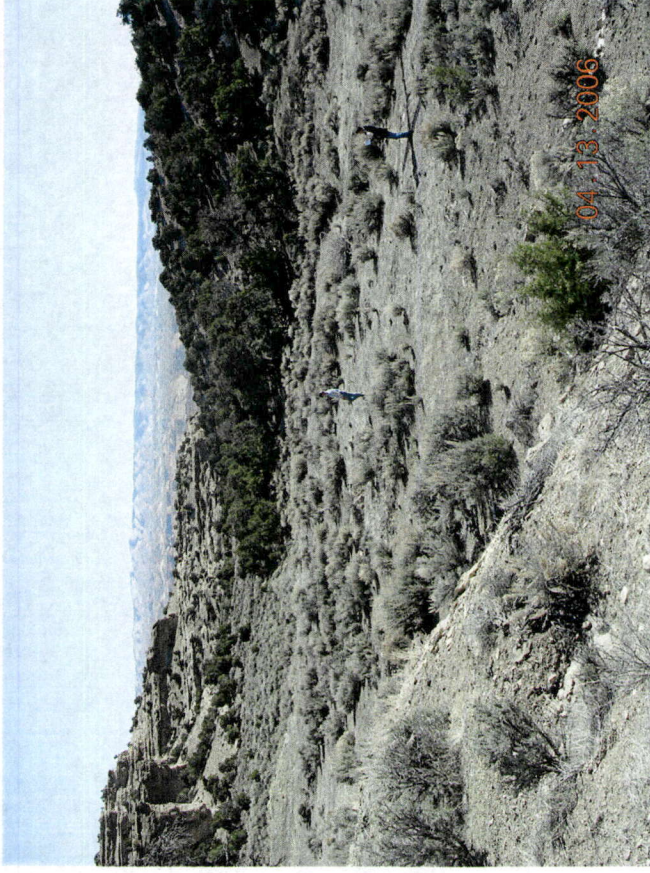
| R4 | 21 & 22 | Reclaimed. Shaft sealed with PUF with no signs of failure. Perennial cover is about 40 percent in reclaimed area and about 50 percent in undisturbed areas. Road reclaimed. |

**Photo 21. Road leading to R4.**

**Photo 22. Overview of R4 area.**

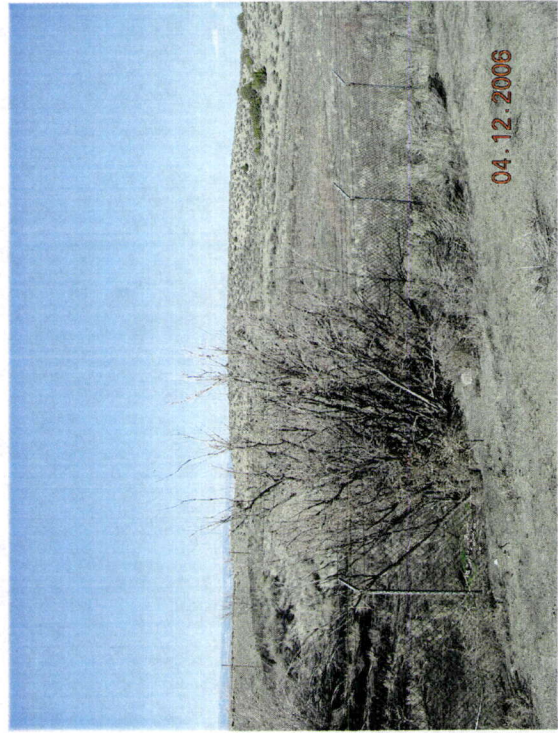
Photo 2. Reservoir.

| Reservoir | 2 | The reservoir is dry. |
